DELAWARE RIVER BASIN  
SCHUYLKILL RIVER  
MONTGOMERY AND PHILADELPHIA COUNTIES

PENNSYLVANIA  
NDS ID PA. 00896  
DER ID 51-1

# FLAT ROCK DAM

PHASE I INSPECTION REPORT  
NATIONAL DAM INSPECTION PROGRAM

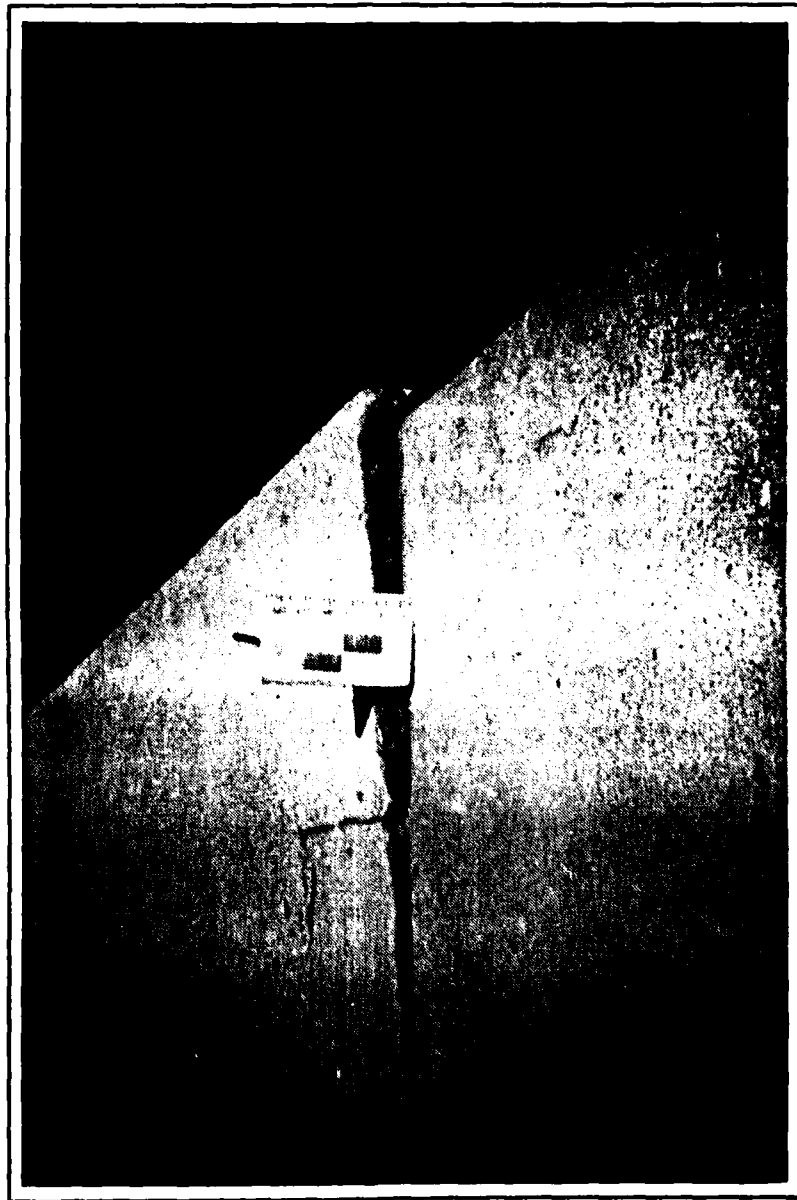
PHOTOGRAPH NO. 11

VERTICAL DISPLACEMENT BETWEEN  
CONSTRUCTION JOINTS, APPARENTLY  
AS CONSTRUCTED.
